Service Report

Report no.: 344
 Report date: Sep 02, 2025
 Location: PORTSAID ANCHORAGE AREA OPL
 Vessel Name: DAKAR
 IMO no.: 9251743

❖ Evaporator No.2 for Control Engine Room AC

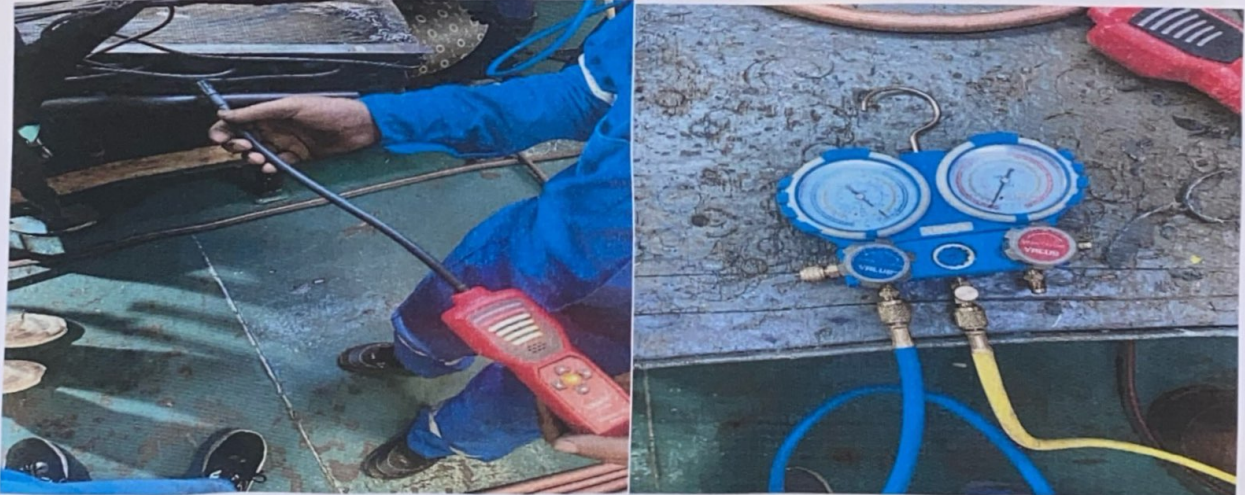
3. We pressurized a freon gas to detect the leakage in evaporator and it shows 2 cracks
There are two methods used to detect the crack: gas leakage detector and soap as shown below (there are videos will be send to you shown the cracks)

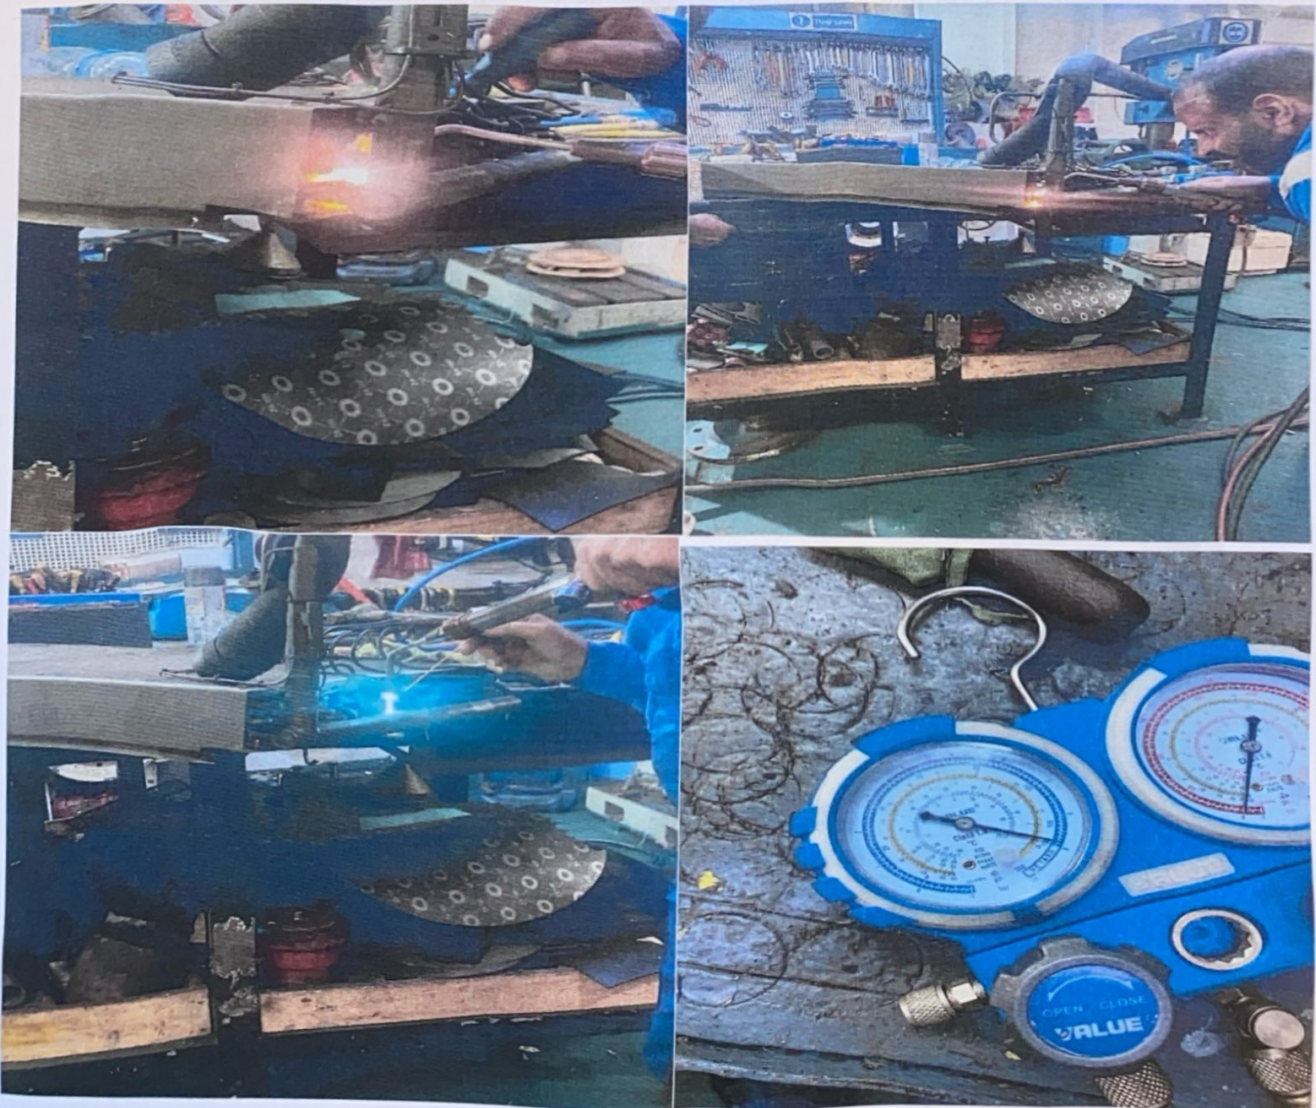
2. Then we pressurized Freon gas into the evaporator and find 5 cracks and welded using gas welding and silver sticks like previous (videos will be send to you showing the cracks)

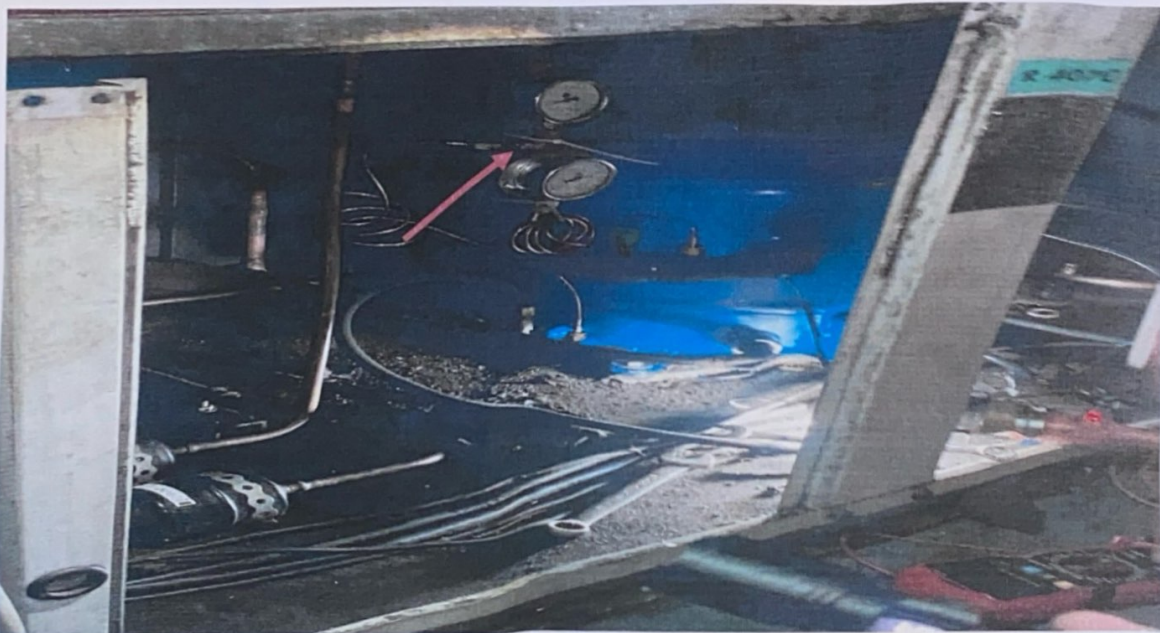
1. Chief engineer asked us he want to change compressor No.1 with No.2 because after we finish when the ETO try to operate the system, we find out the No.1 compressor is burned
2. On 2nd Engineer demand, we fabricate a special connection to make a high-pressure gauge for the system No.2

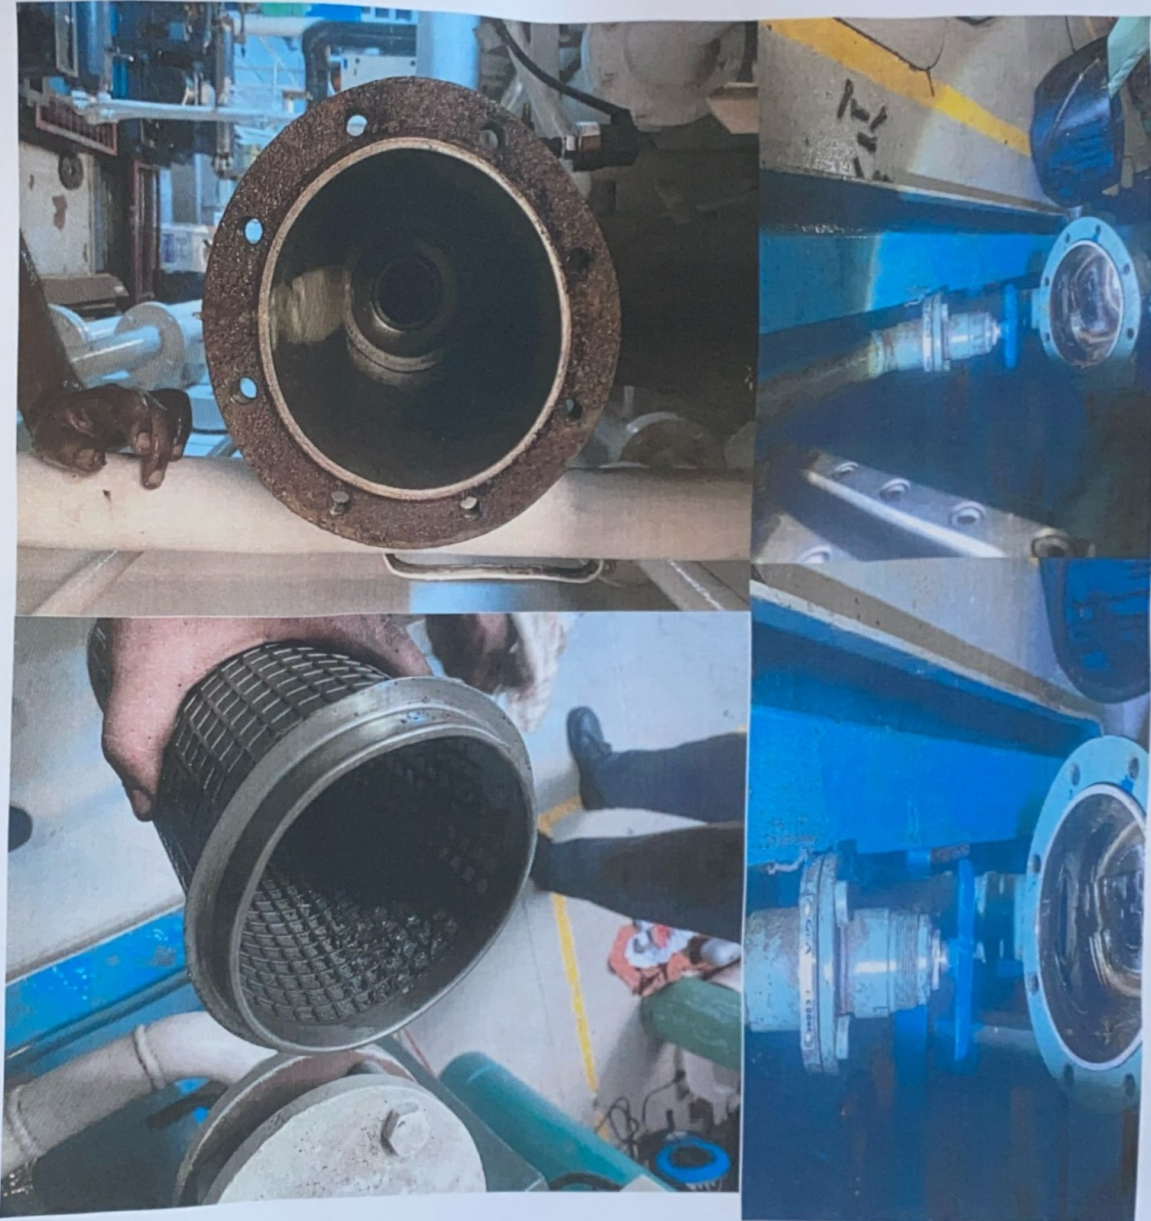
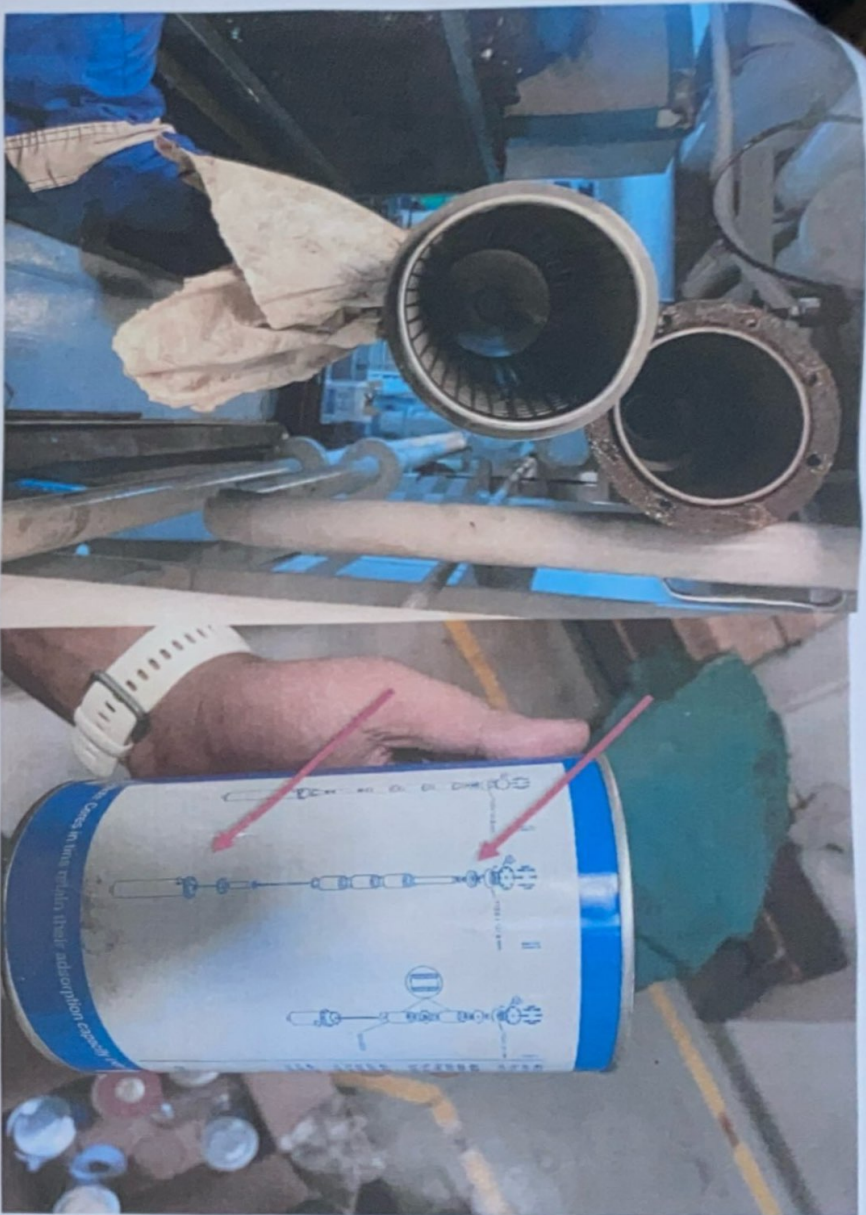
1. The dryer filter found with no dryers inside and dirty so we clean it but we can't put dryer because connections not available onboard as shown below
