Service Report

Report no.: 233

PORTSAID ANCHORAGE AREA OPL

Job: Boiler Repair

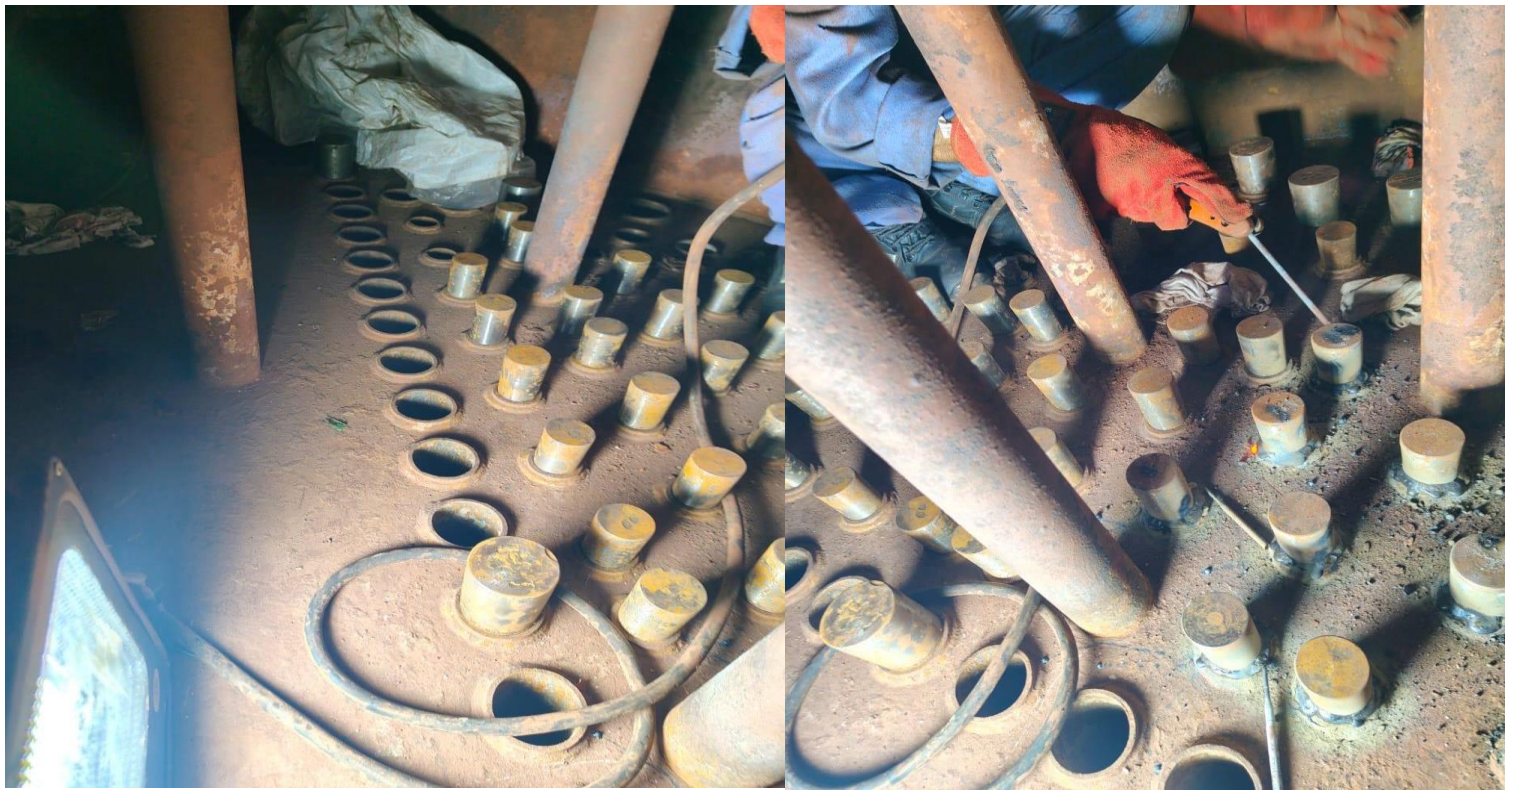
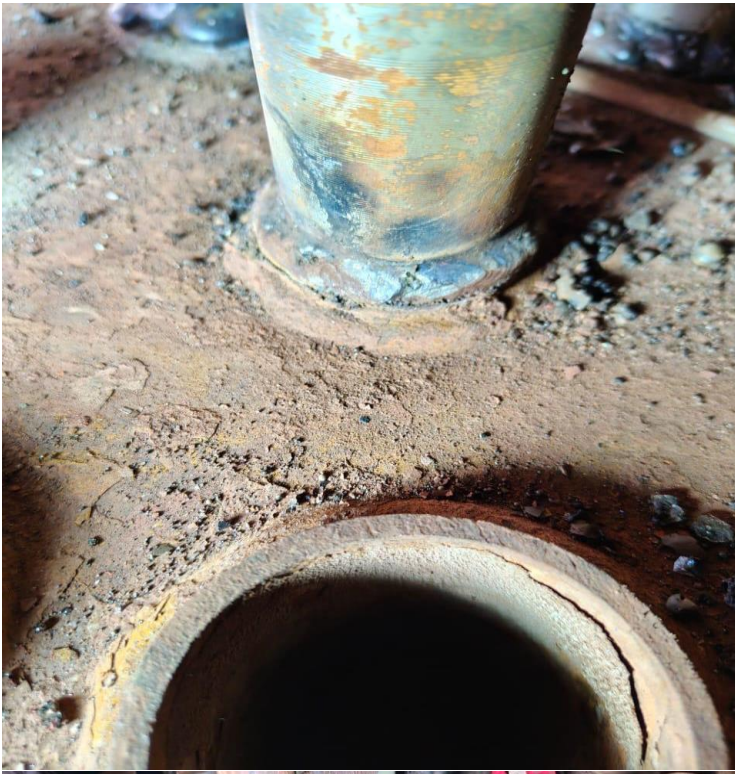
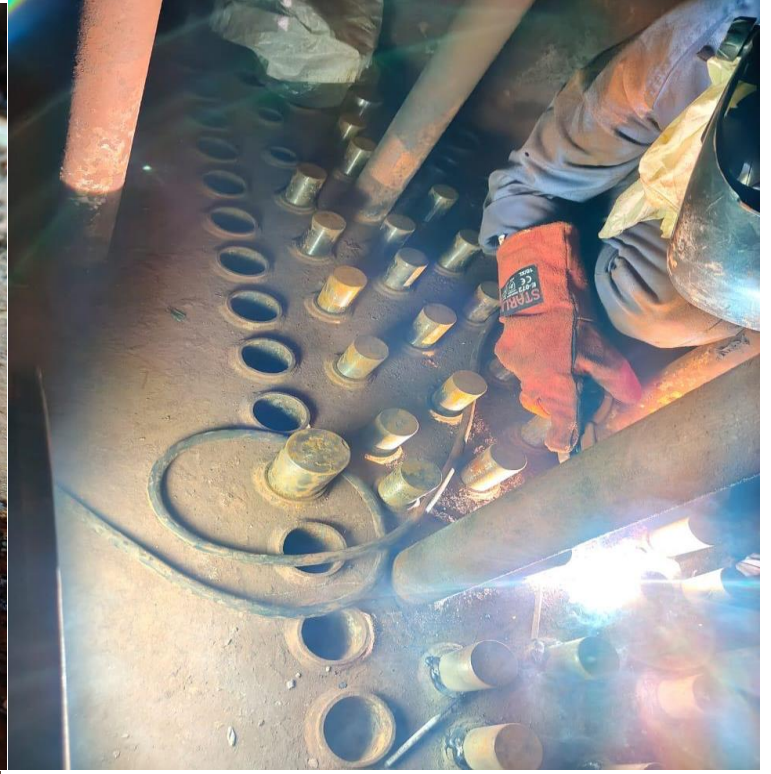
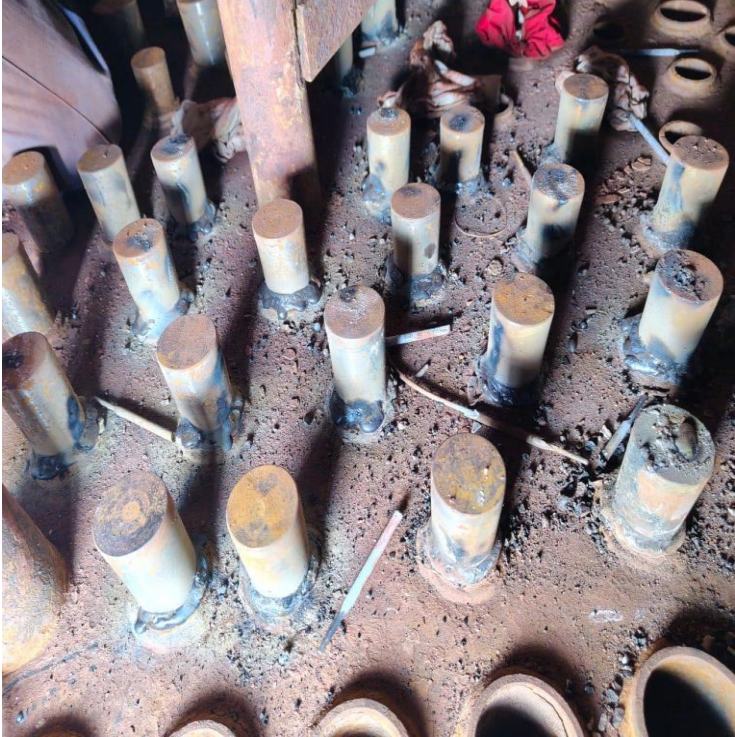
We found that most of the plugs were already in place upon our arrival on board, therefore we prepared the necessary tools and immediately started the welding process, as shown in the photos.

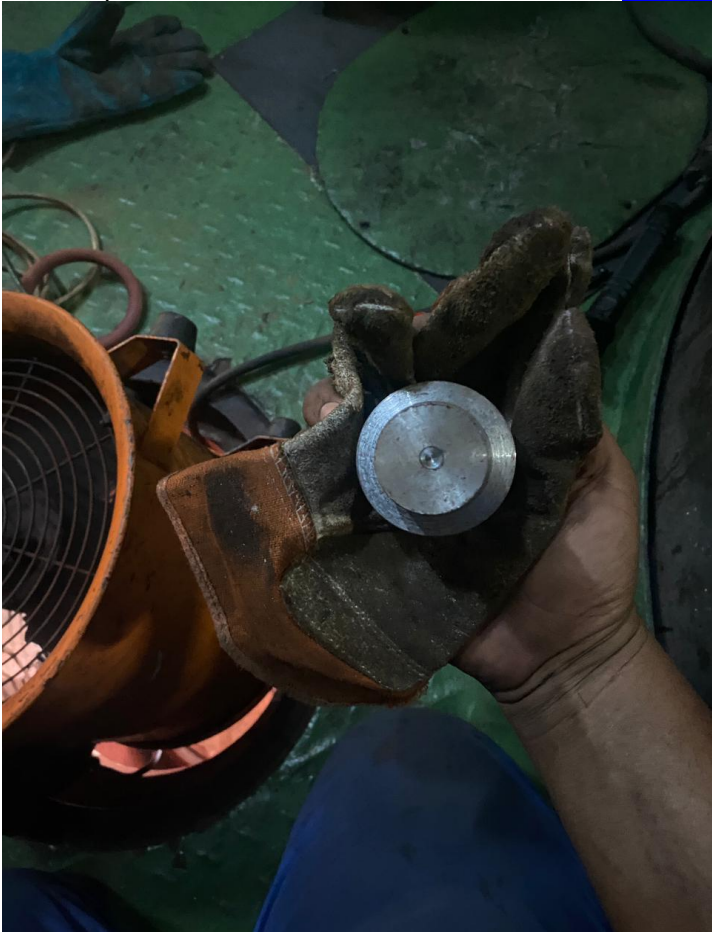
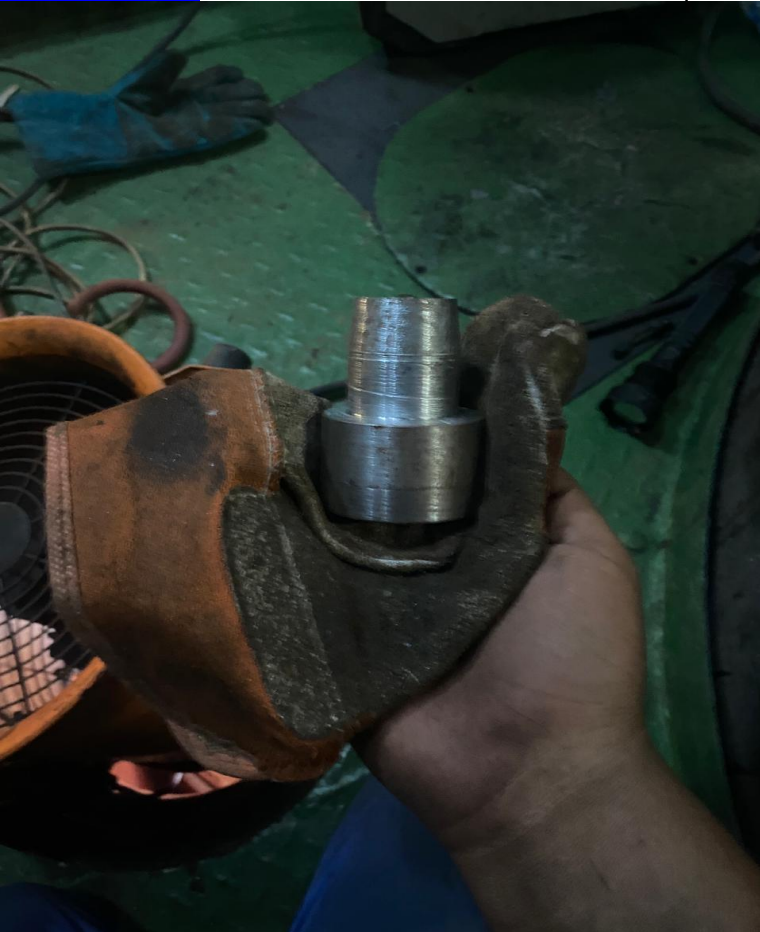
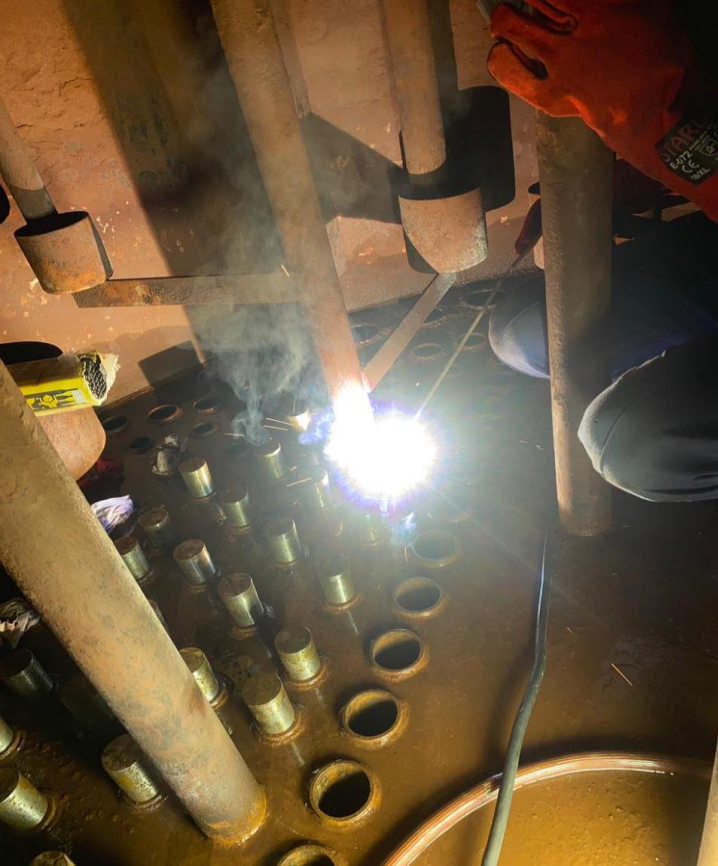
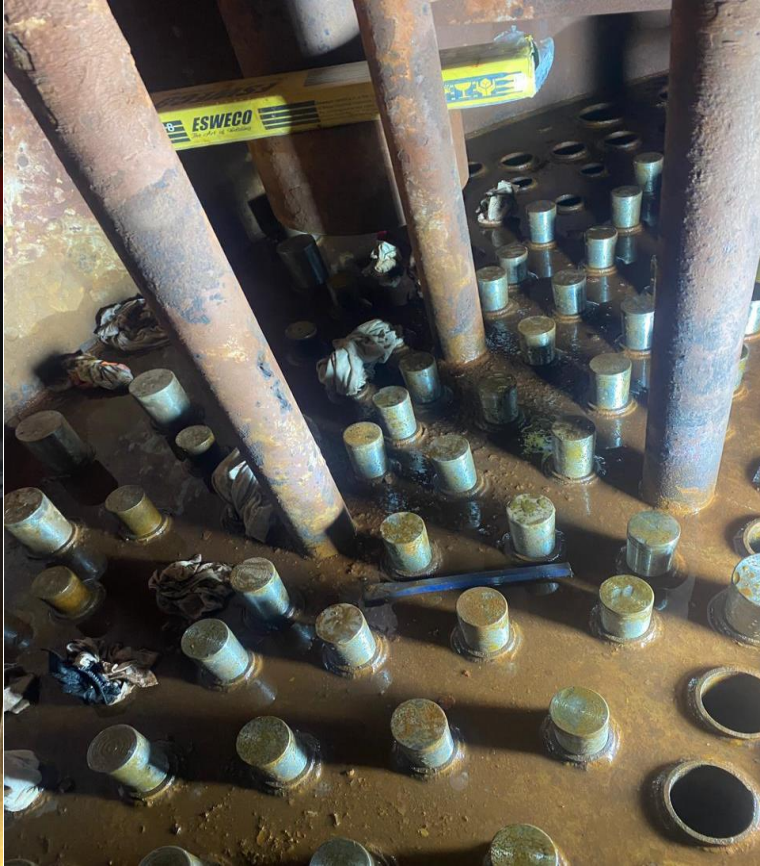
After that, we found that some of the plugs did not match the required dimensions, so we had to fabricate new plugs using the lathe machine. Each plug took around 20 to 25 minutes to manufacture, which caused a delay in the work progress.

Approximately 15 new plugs were fabricated for the upper side of the boiler, and a total of around 80 plugs were welded on the upper side of the boiler as shown in pictures.

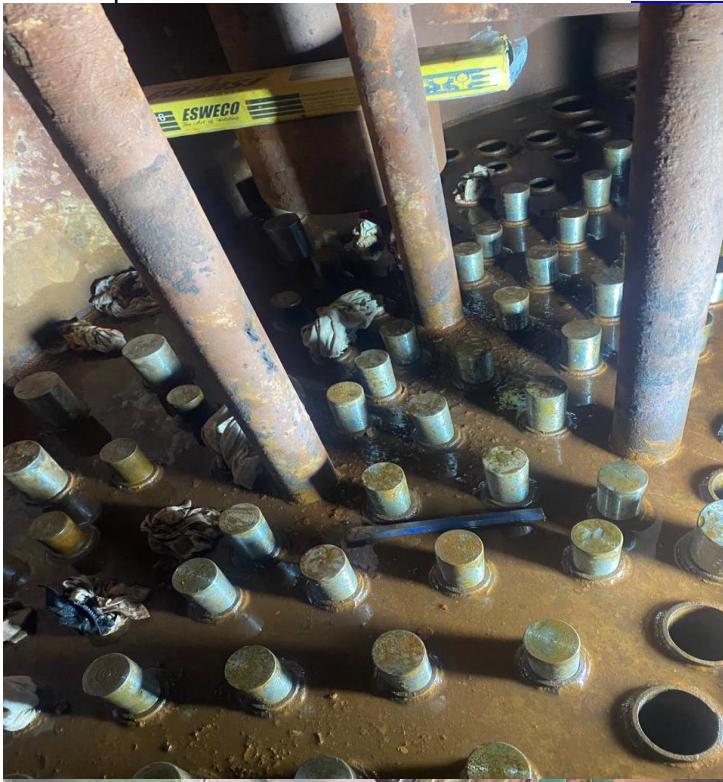
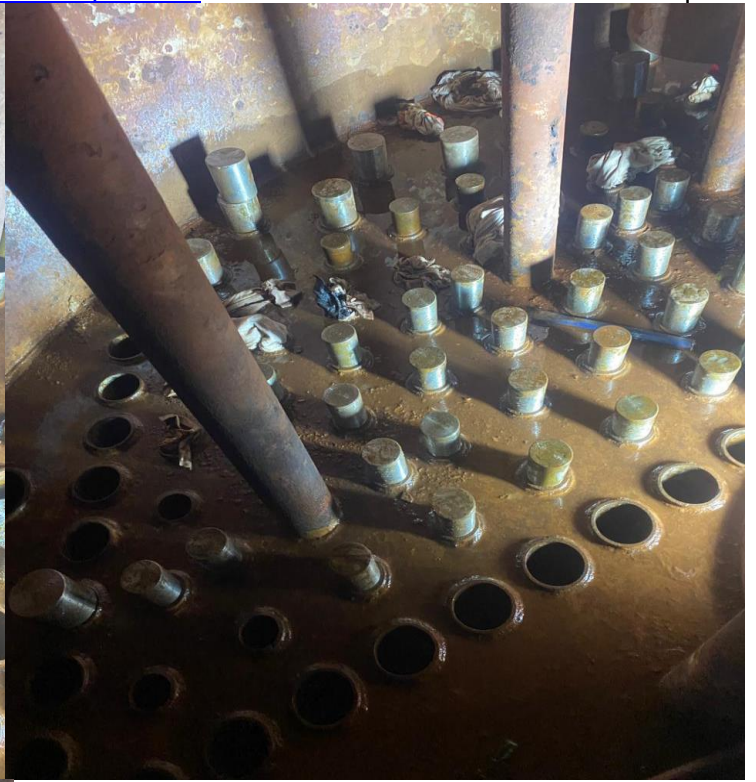
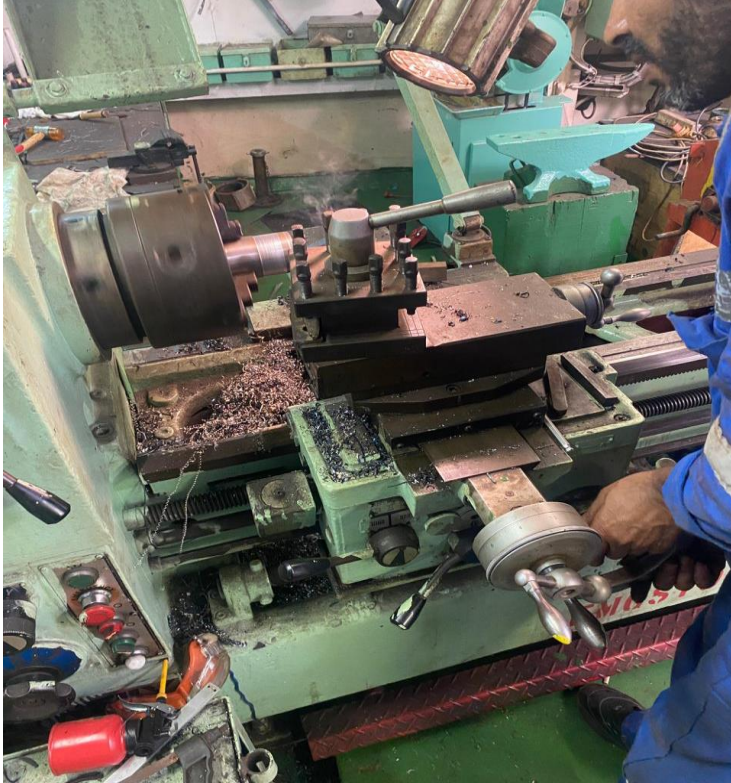
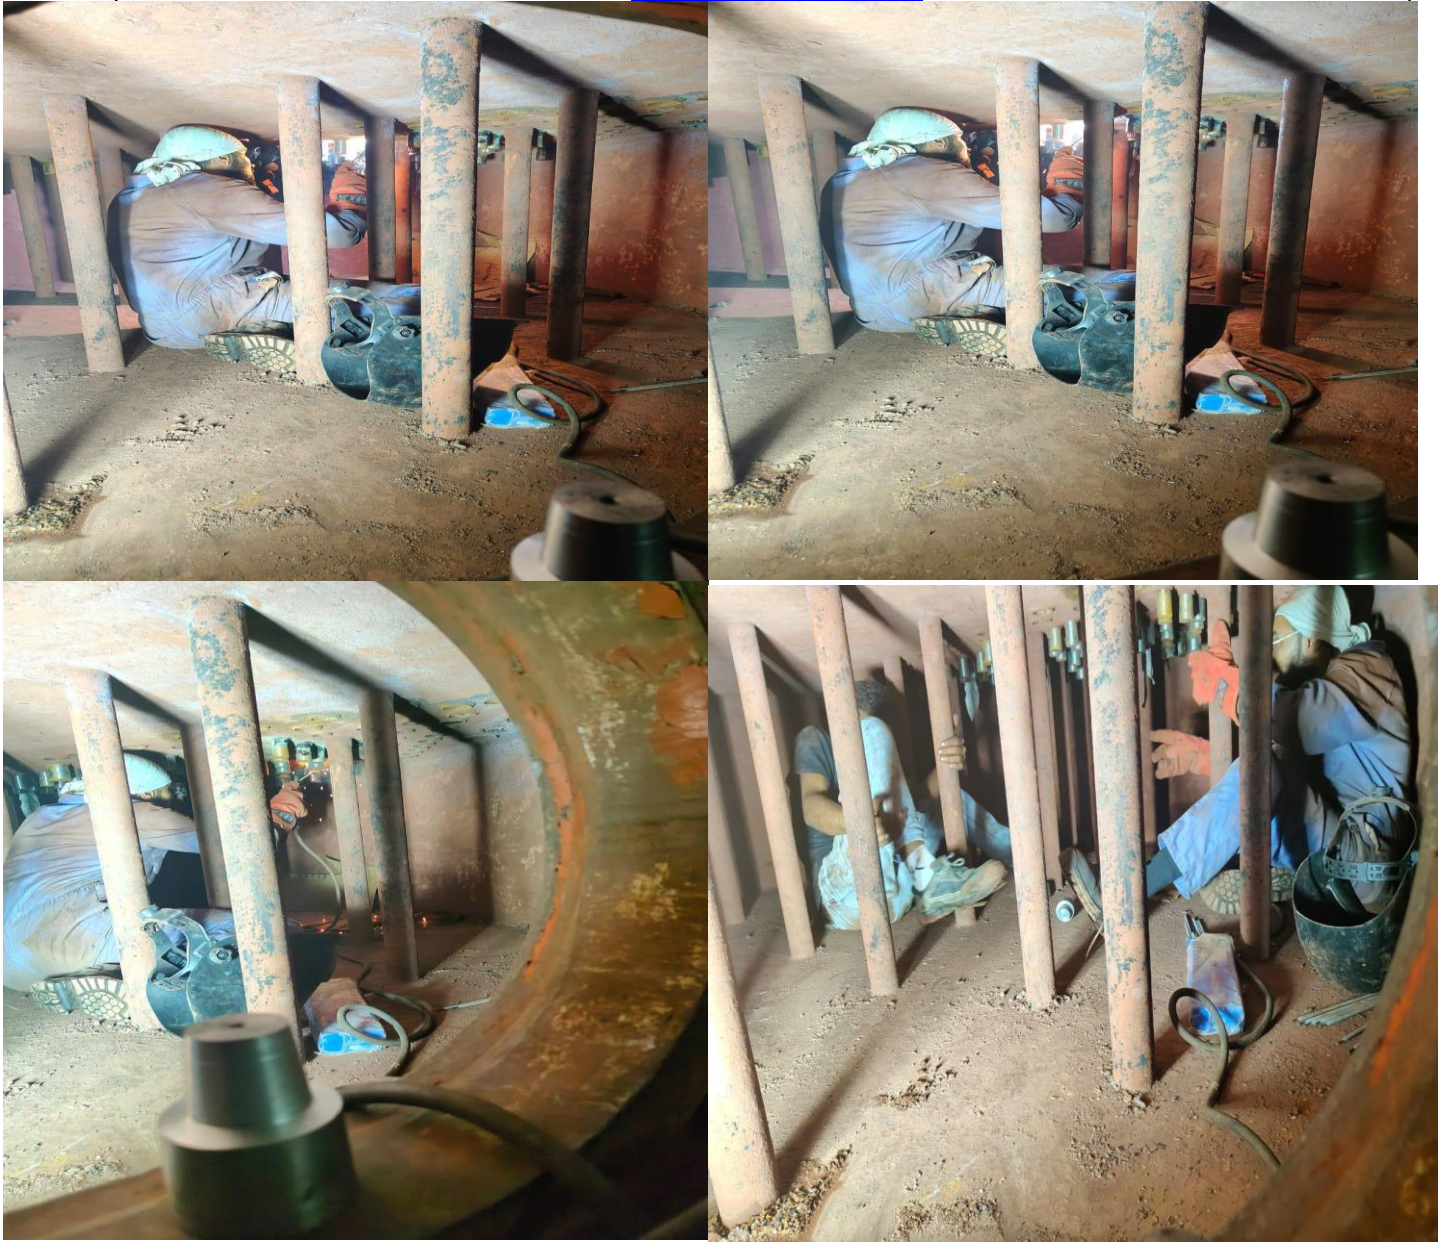
Then we proceeded to the lower side of the boiler, where the same number of plugs were manufactured and welded as well as shown in pictures.

So, the total number of the welded plugs are approximately 160 Plugs and the fabricated are 30 plugs.
