# Service Report

Report no.: 432

Vessel Name: CAPE ZOYA

## Final Report

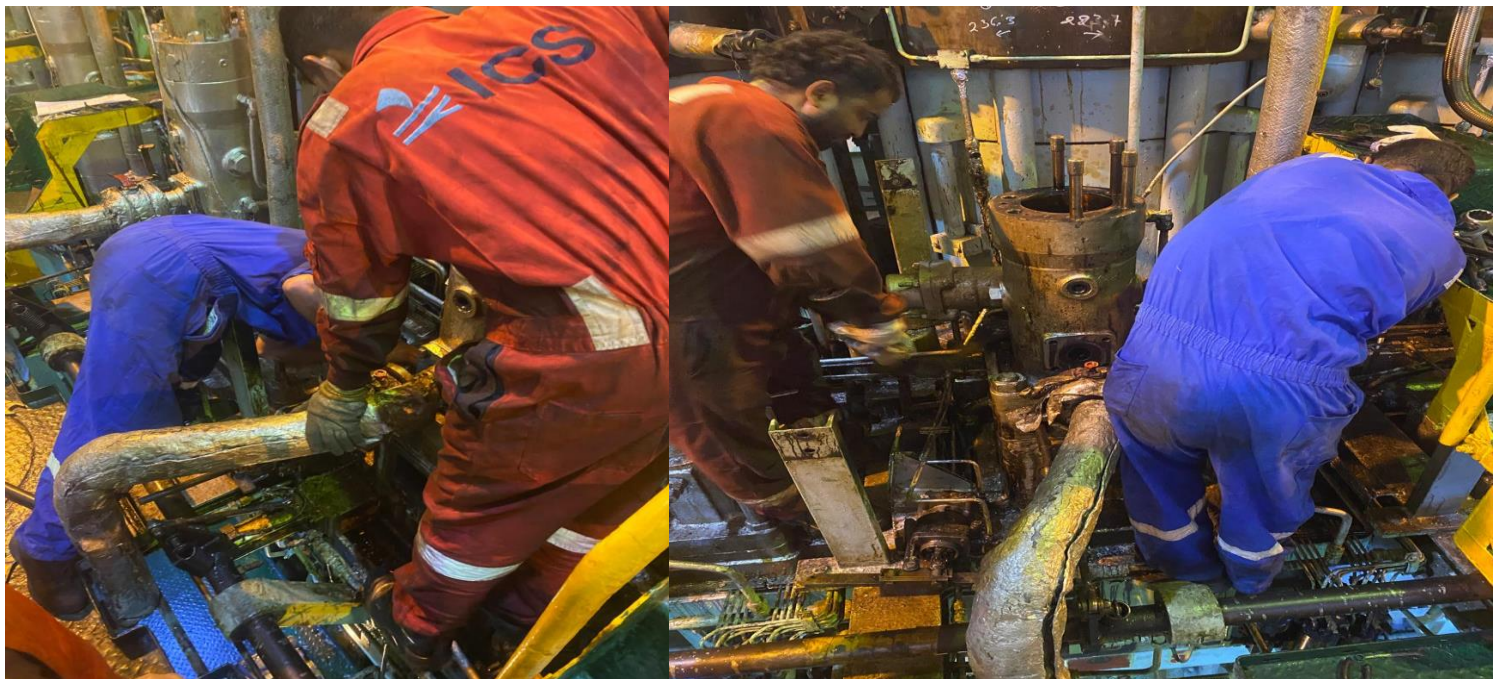
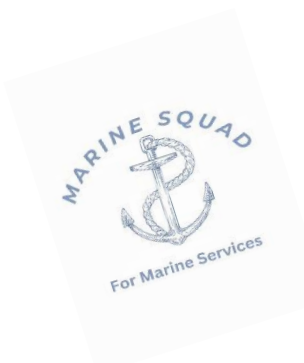
Upon inspection, an operational anomaly was identified: **the fuel rack control linkage with its actuating arm was observed protruding abnormally outward**, indicating improper assembly and mechanical binding risk.

Recognizing the critical nature of fuel injection controls, the team decided to completely dismantle the pump assembly to investigate root causes, verify internal components, and restore the mechanism to standard operating compliance.

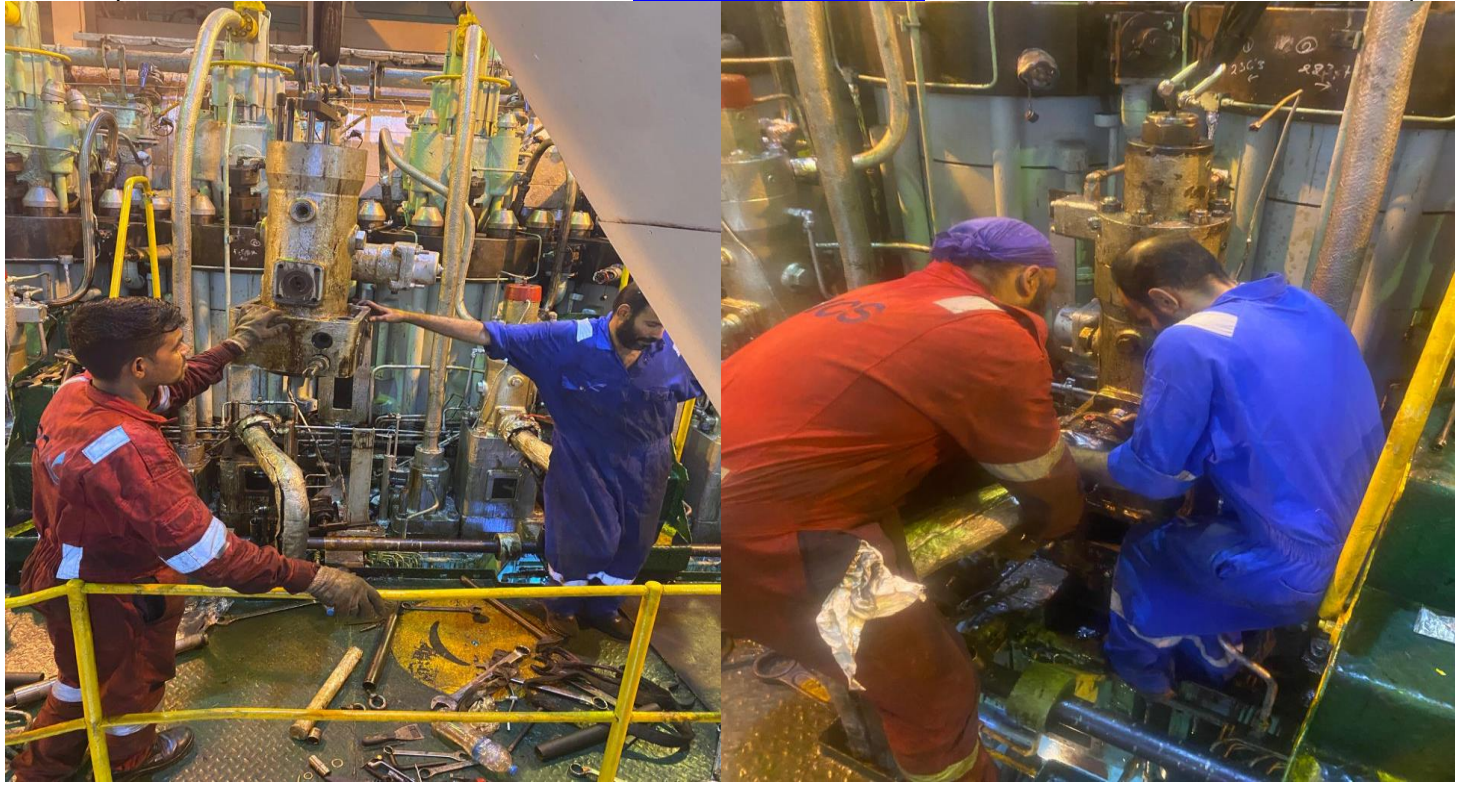
Following the complete disassembly of the fuel injection pump, a thorough internal examination revealed the primary source of the anomaly:

**Missing Safety/Locking Component:** The internal safety locking mechanism/pin of the operating arm had been omitted during the previous reassembly attempt by the crew.

**Rack Misalignment:** Due to the missing safety restraint, the fuel rack and lever arm were displaced from their designated tracking groove, resulting in the abnormal outward projection observed.
