# Service Report

SUEZ ANCHORAGE AREA

Vessel Name: GMT ASTRO

## Final Report

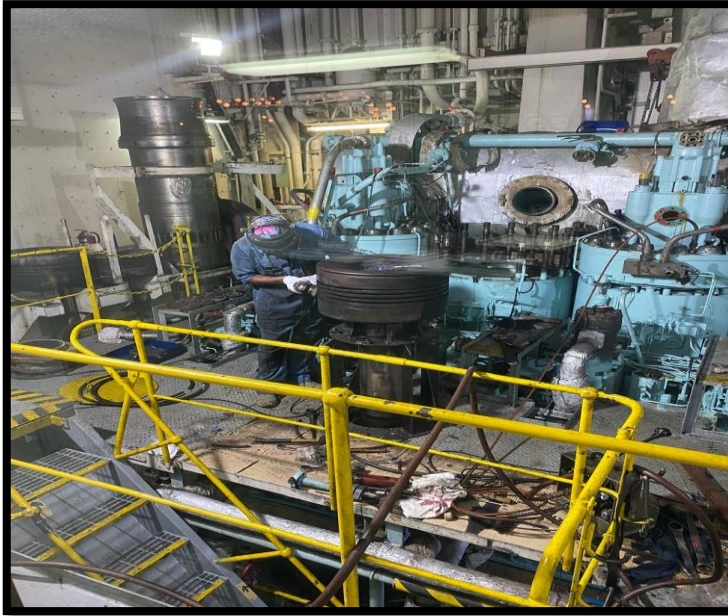
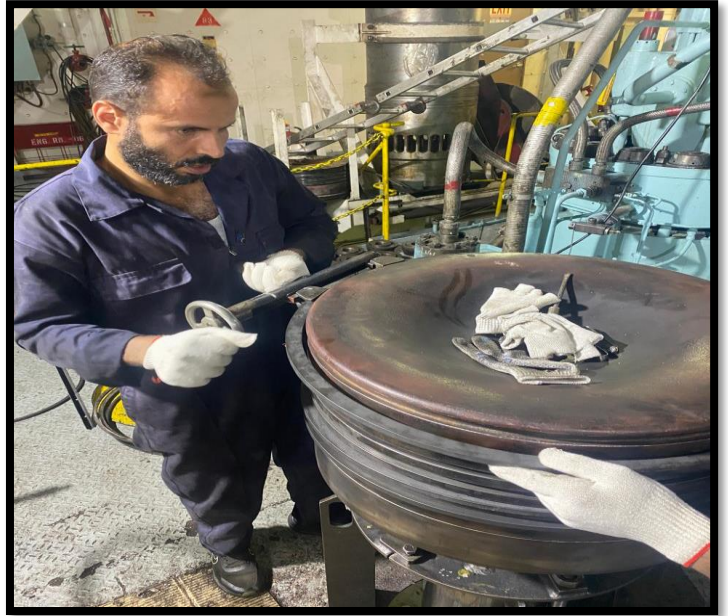
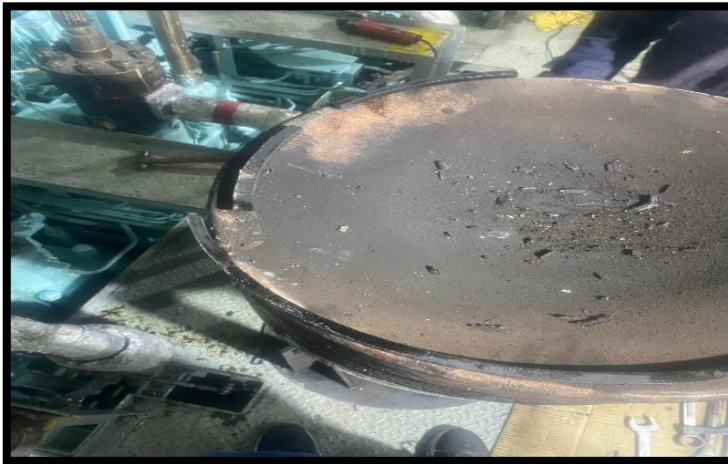
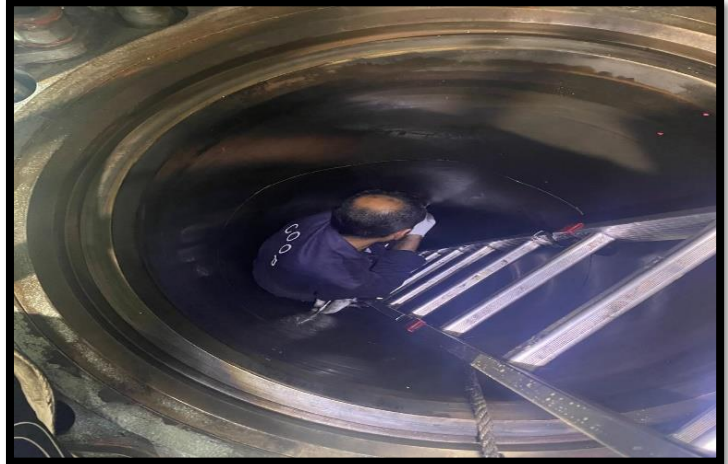
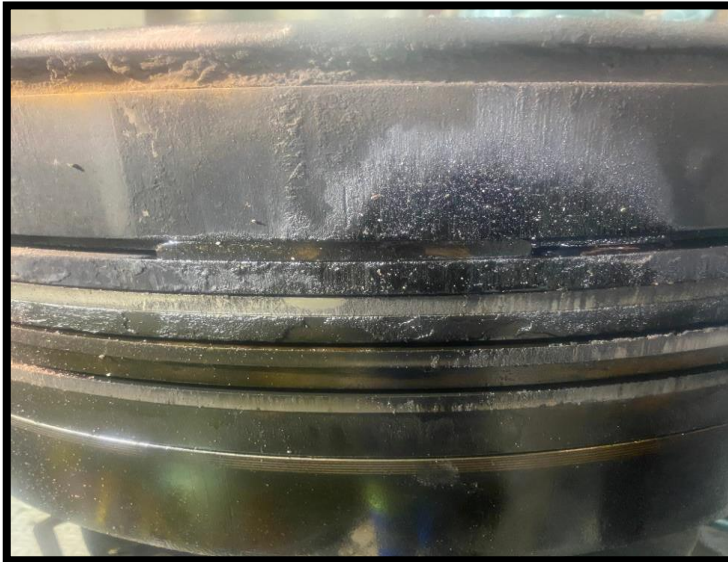
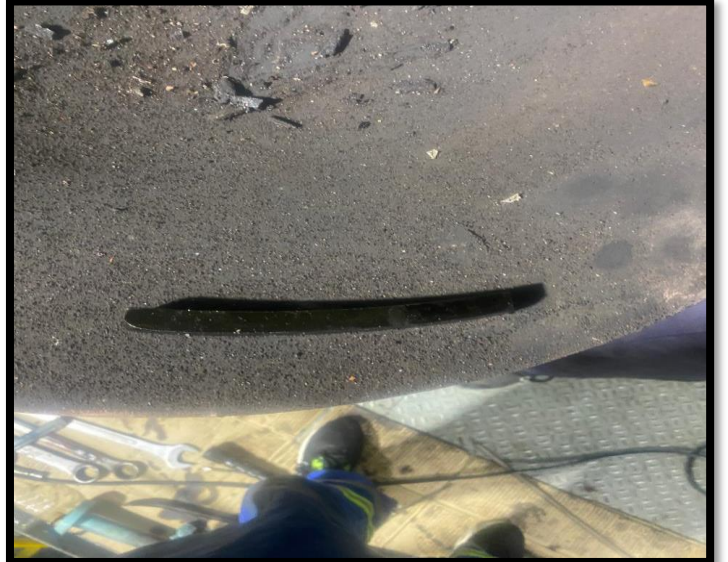
### 1. Dismantling Cylinder cover, Piston of Unit No. 2

Start dismantling cylinder cover and piston, we find out a damaged in the piston rings

Then take all our measurements of the piston and rings as shown in the pictures

The crown clearance was taken at 4 points

Max. = 1.3 mm

Min.= 0.3 mm

So, we clean the piston, stuffing box and clean all grooves of piston

Finally, we install a new rings, piston and cylinder cover

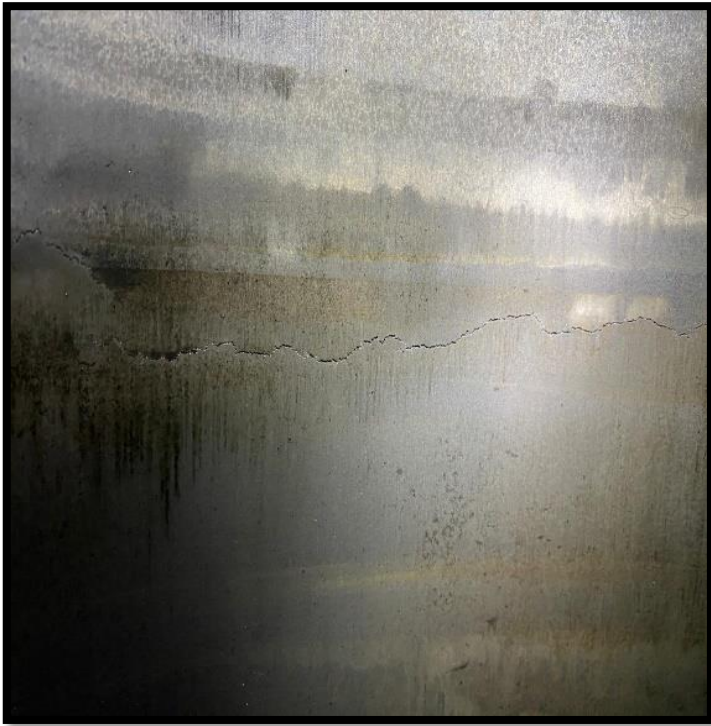
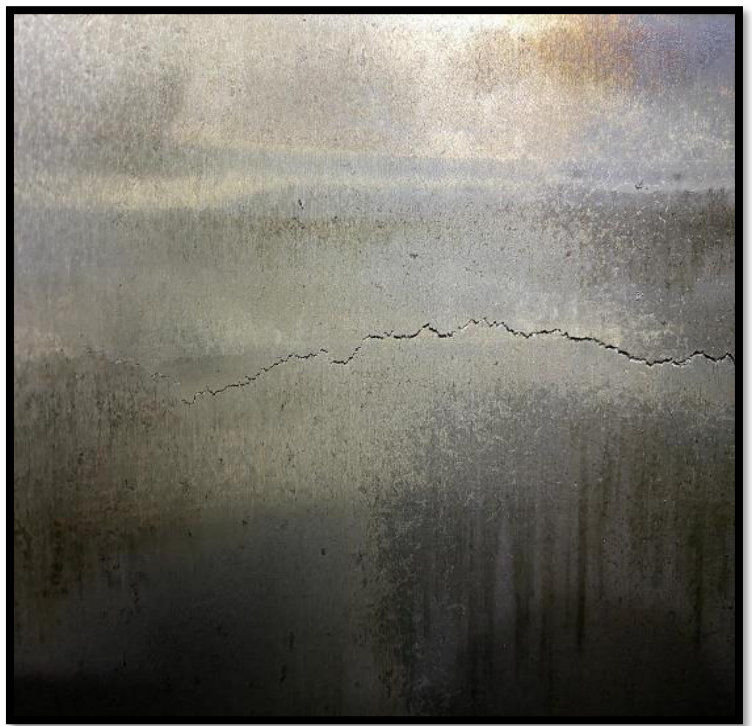
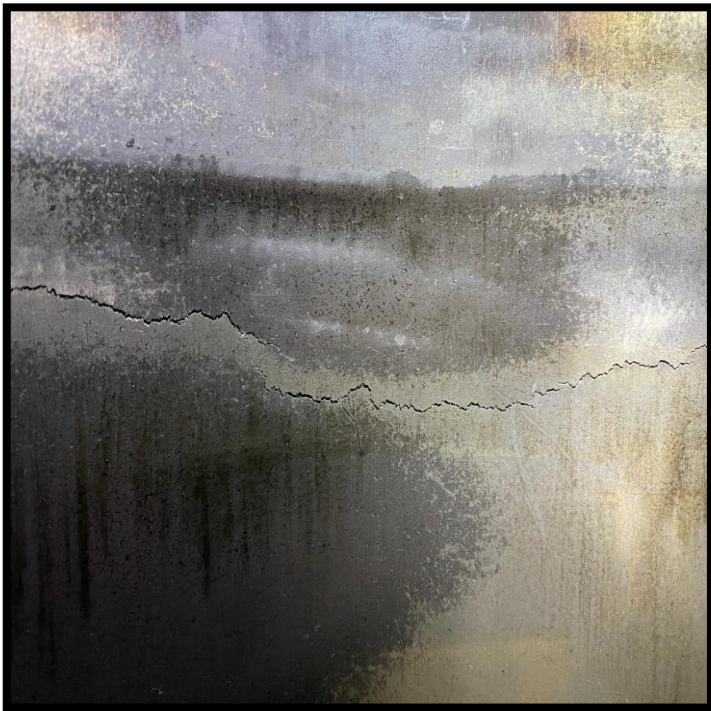
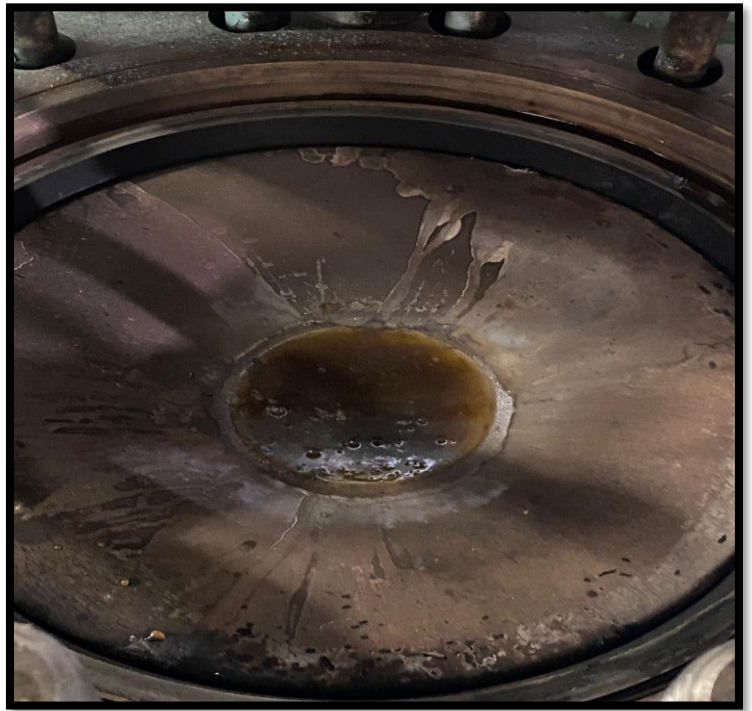
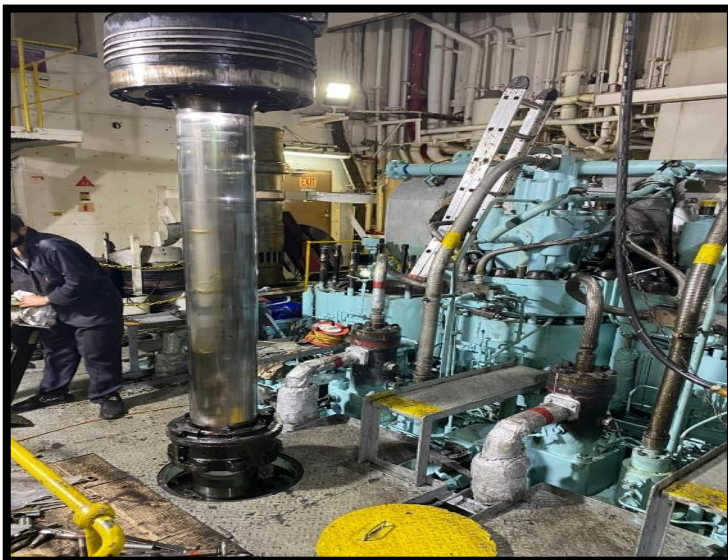
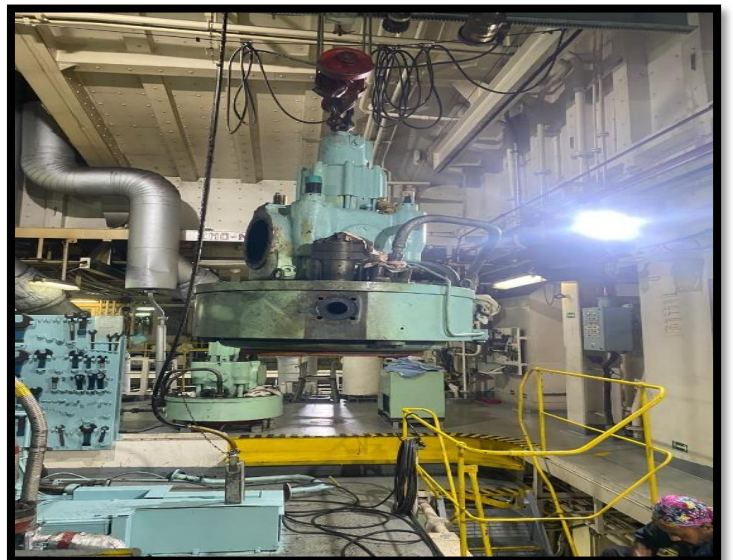
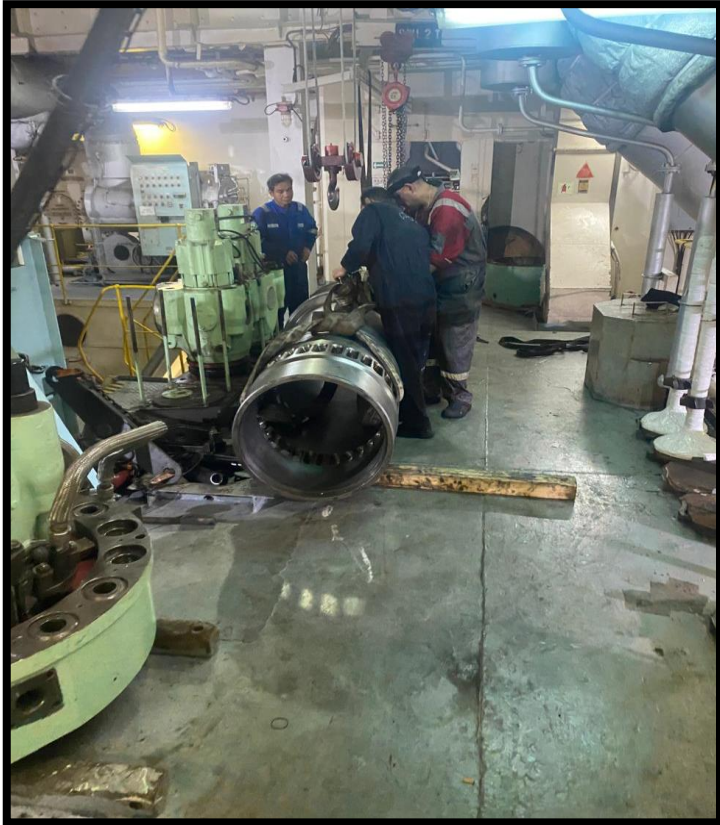
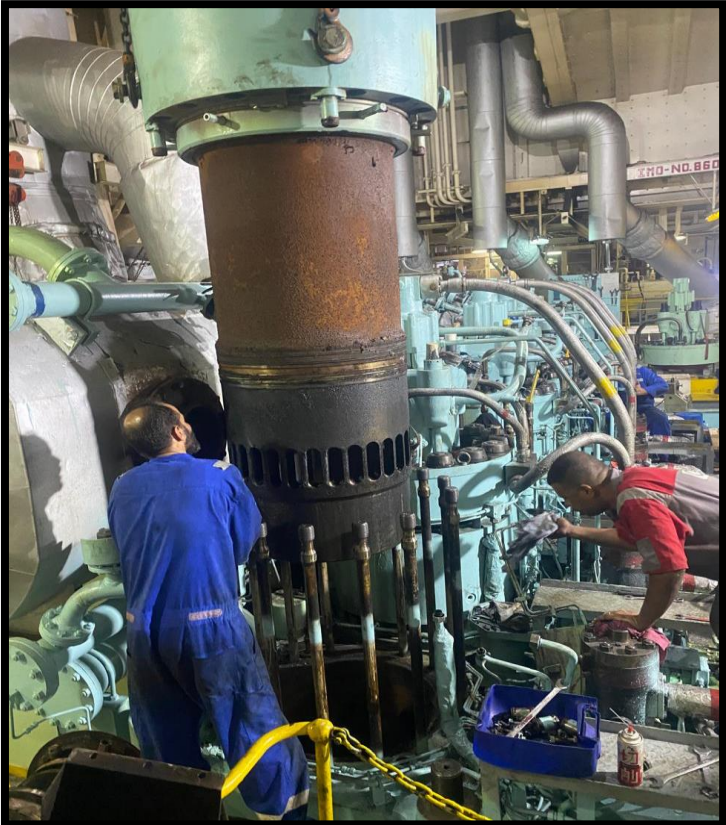
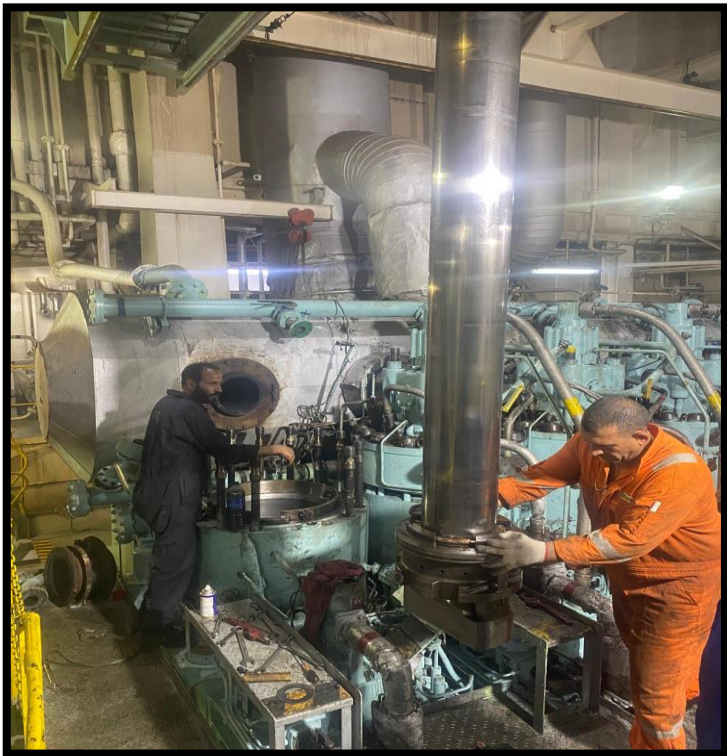
## 2. Dismantling Cylinder cover, Piston And cylinder linear of Unit No.1

After we finish dismantling cylinder cover and piston, we find out a crack in the cylinder linear so we have to change it.

Then take all our measurements of the piston, rings and also check the new linear dimensions as shown in the pictures

Crown Clearance was taken in 4 points  
Max.= 1.1 mm                      Min.= 0.2 mm

So, we clean the piston, stuffing box and clean all grooves

6. We suspect the linear of unit no.1 has been cracked because of thermal stresses

7. We see to much rust and dirty when we dismantle the linear of unit no.1. so, we recommend to blow down the water from the system and chemically treated.

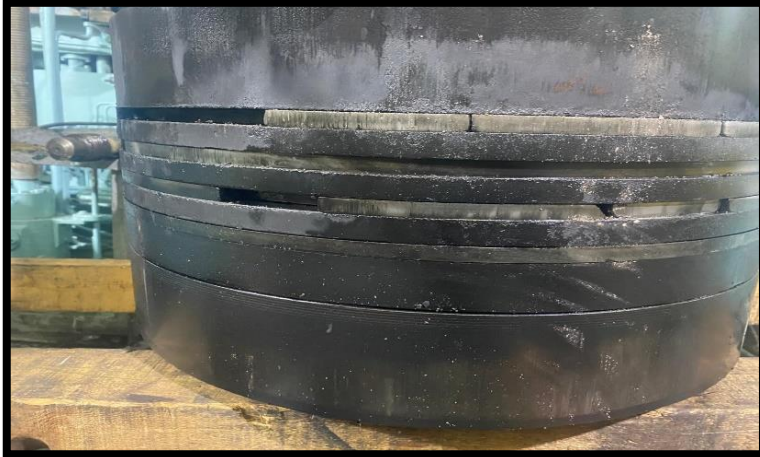
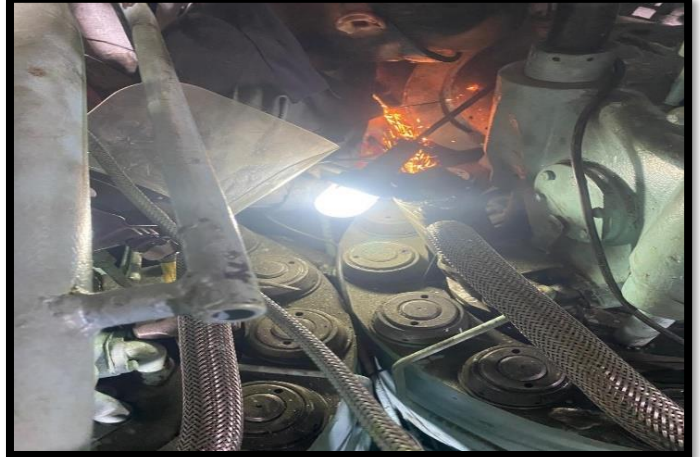
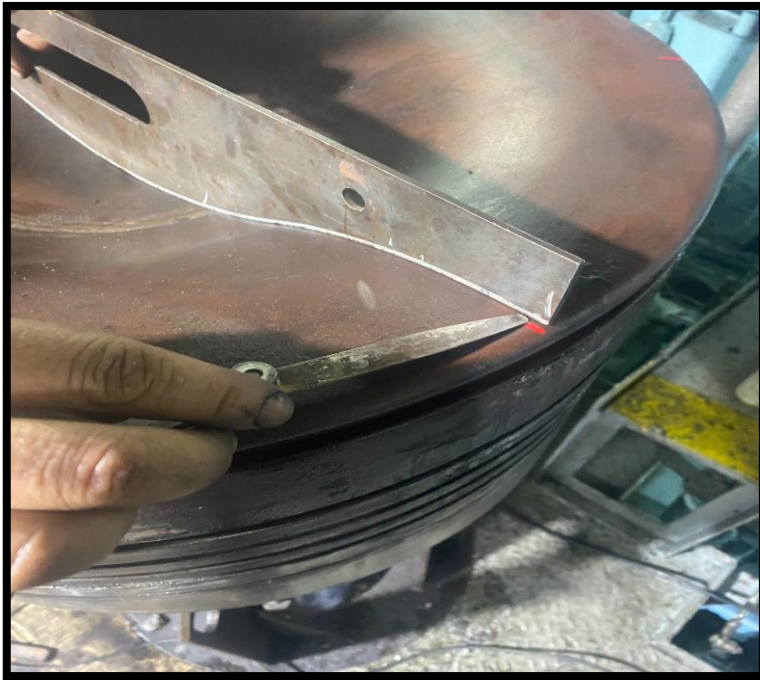
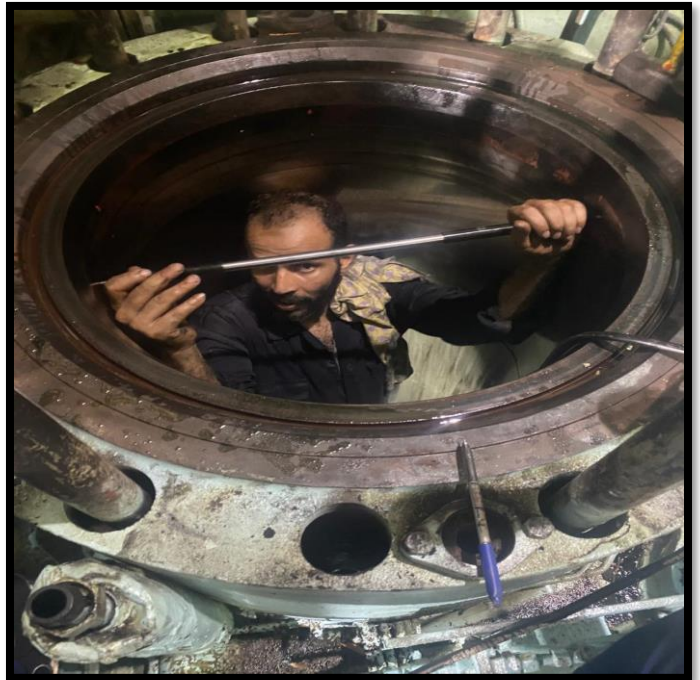
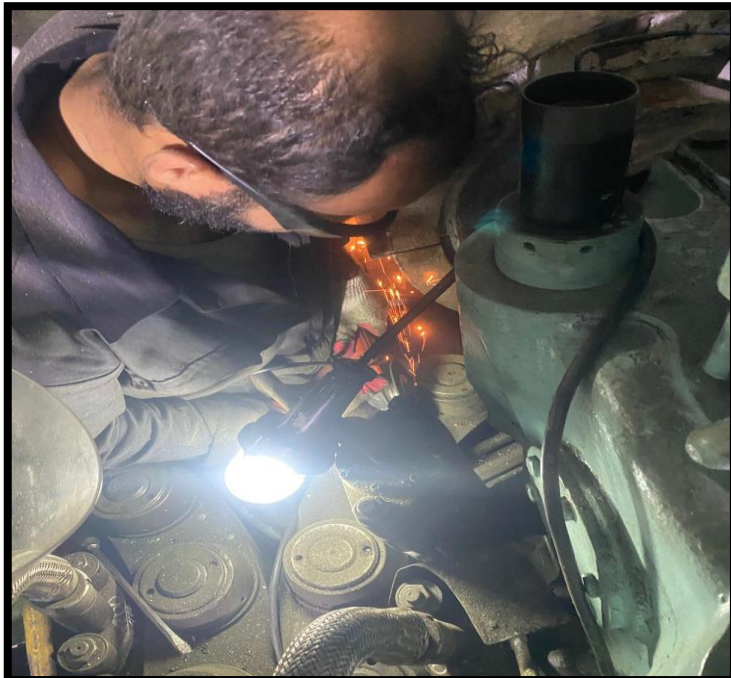
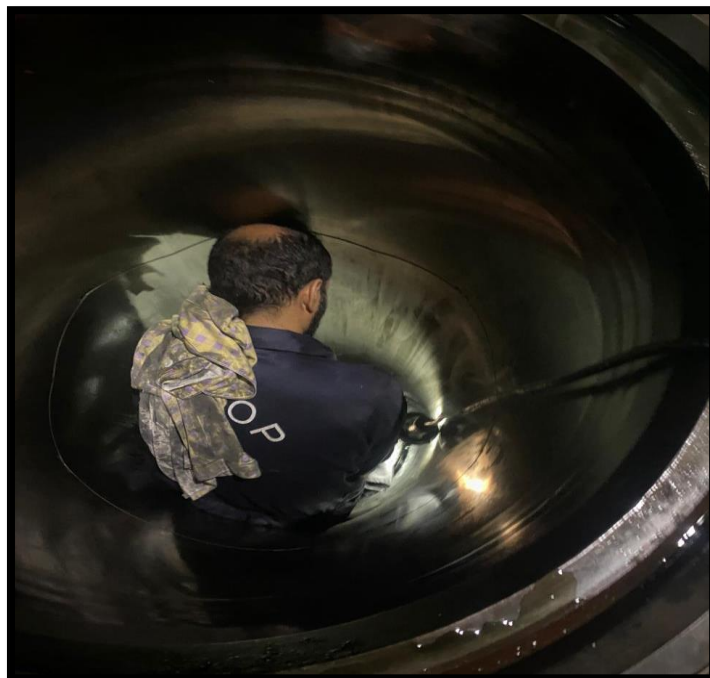
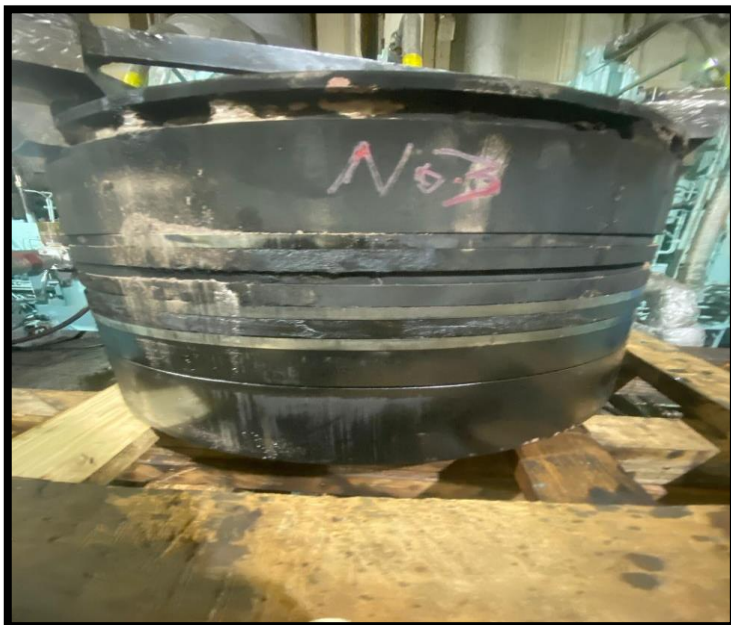
### 3. Dismantling Cylinder cover, Piston And cylinder linear of Unit No.3

Start dismantling cylinder cover but we have found a hydraulic leak in the cylinder cover nut, so we had to cut the nut to replace it.

It took about 4 hours to cut as it was in tight space

we find out a damaged in the piston

Then take all our measurements of the piston as shown in the pictures

So, we clean the piston, stuffing box and clean all grooves of piston

Finally, we install a new rings, piston and cylinder cover

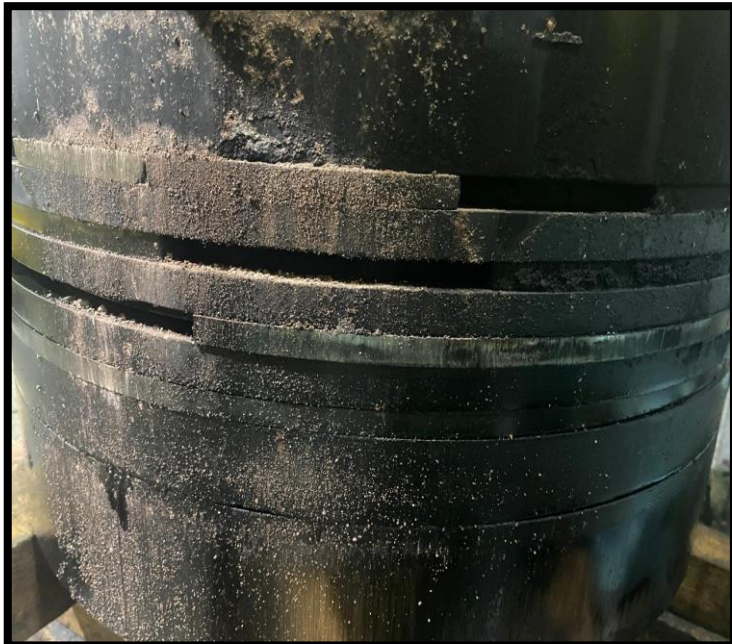
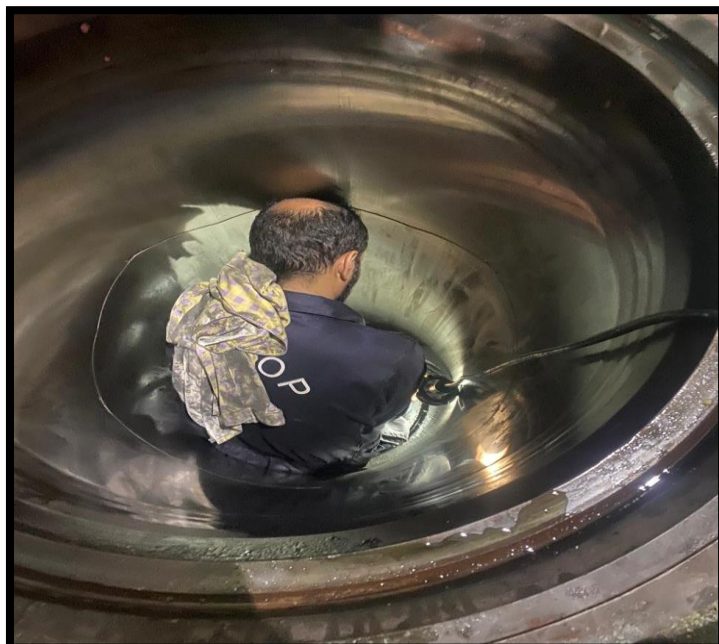
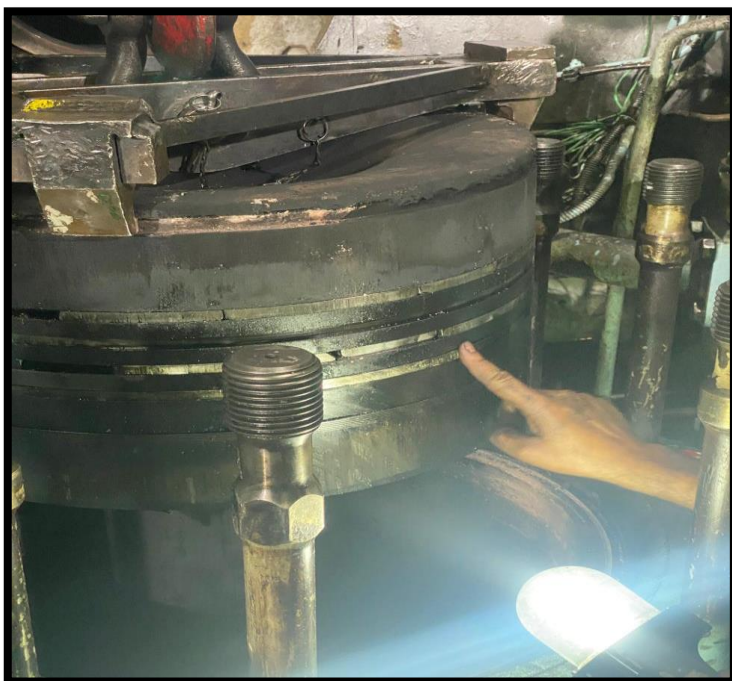
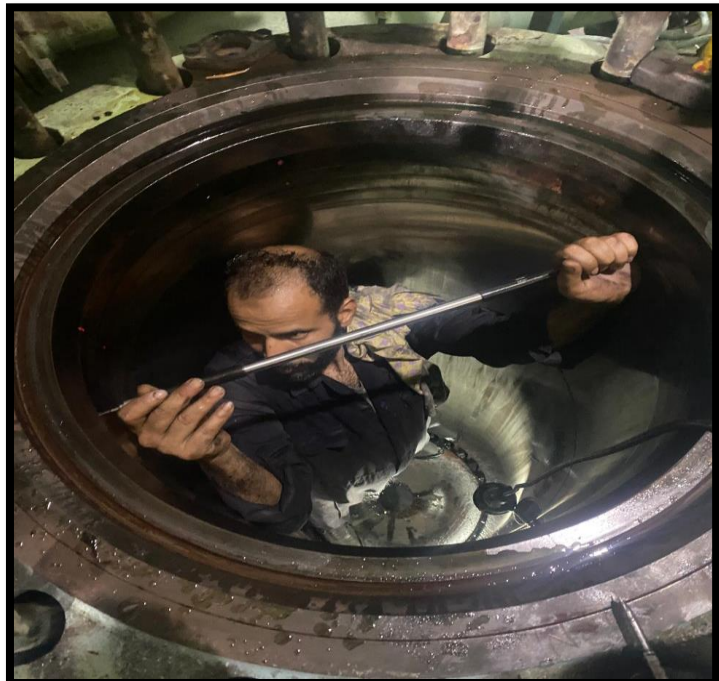
#### 4. Dismantling Cylinder cover, Piston And cylinder linear of Unit No.5

we find out a damaged in the piston rings

Then take all our measurements of the piston as shown in the pictures

The crown clearance was taken in 4 points

Max.= 0.6 mm

Min.= 0.5 mm

So, we clean the piston, stuffing box and clean all grooves of piston

Finally, we install a new rings, piston and cylinder cover

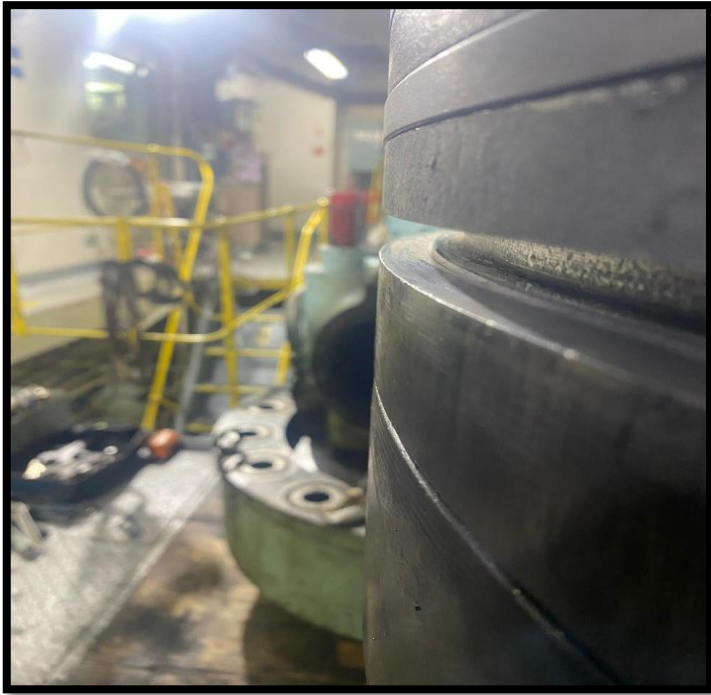
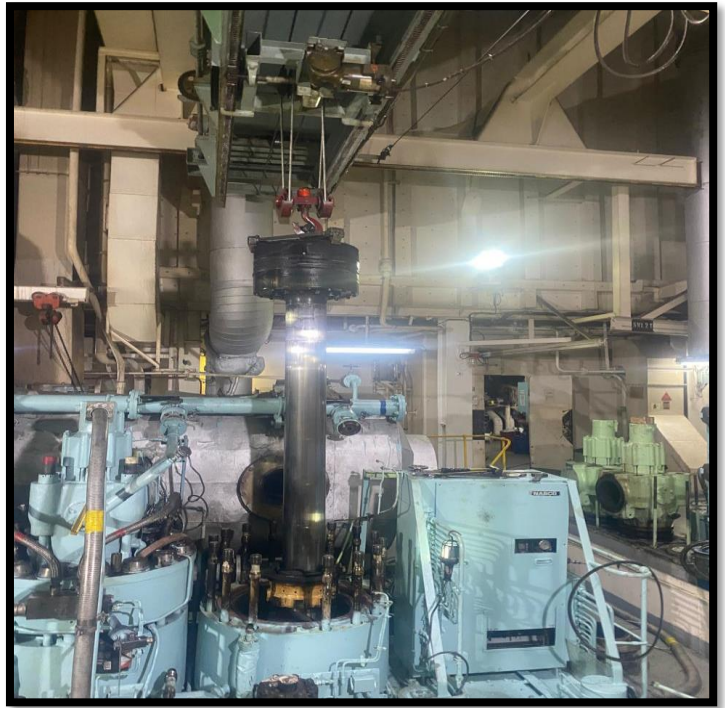
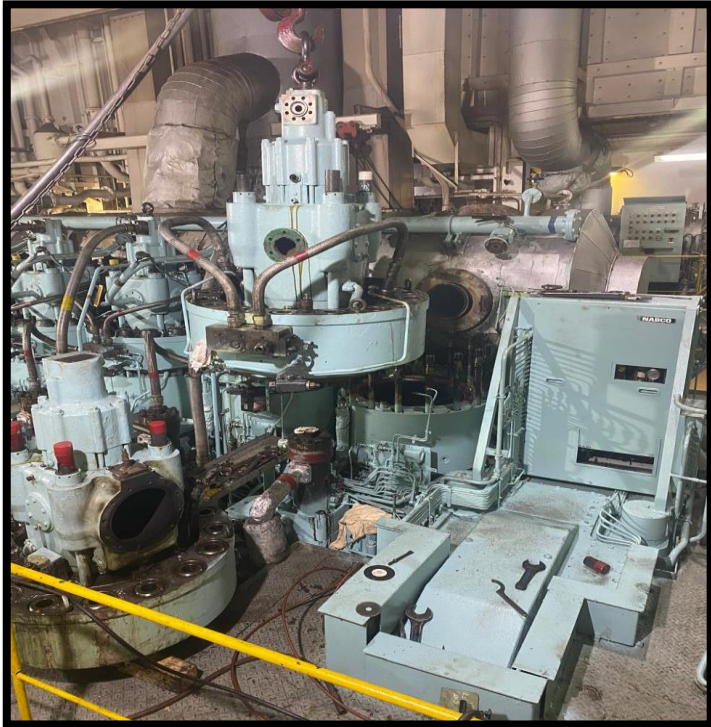
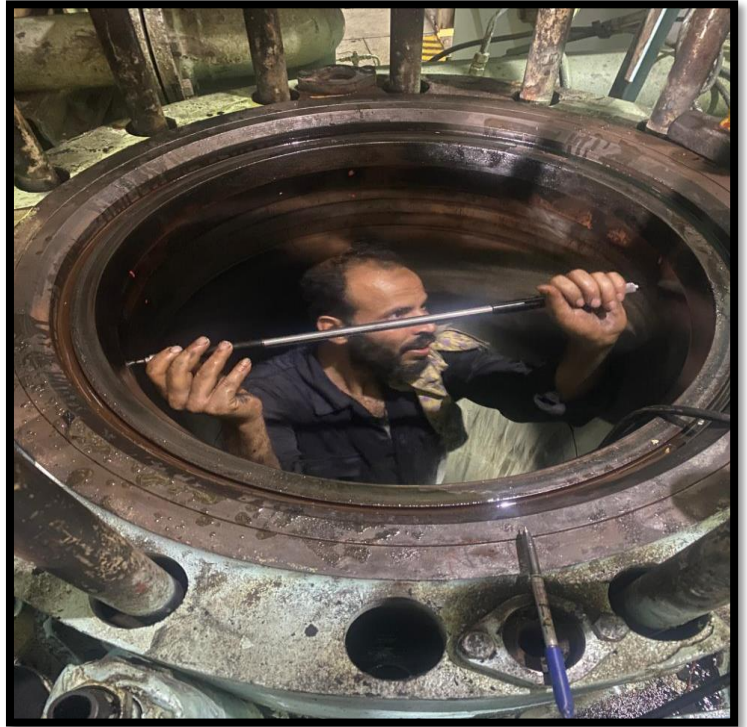
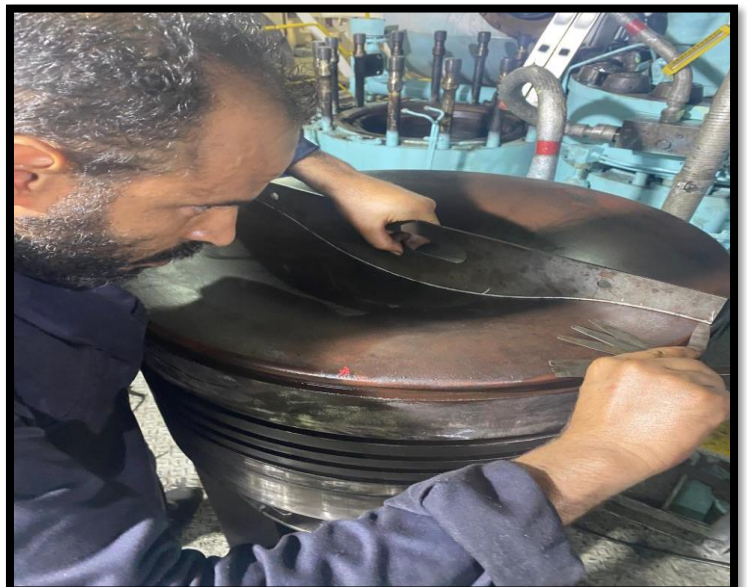
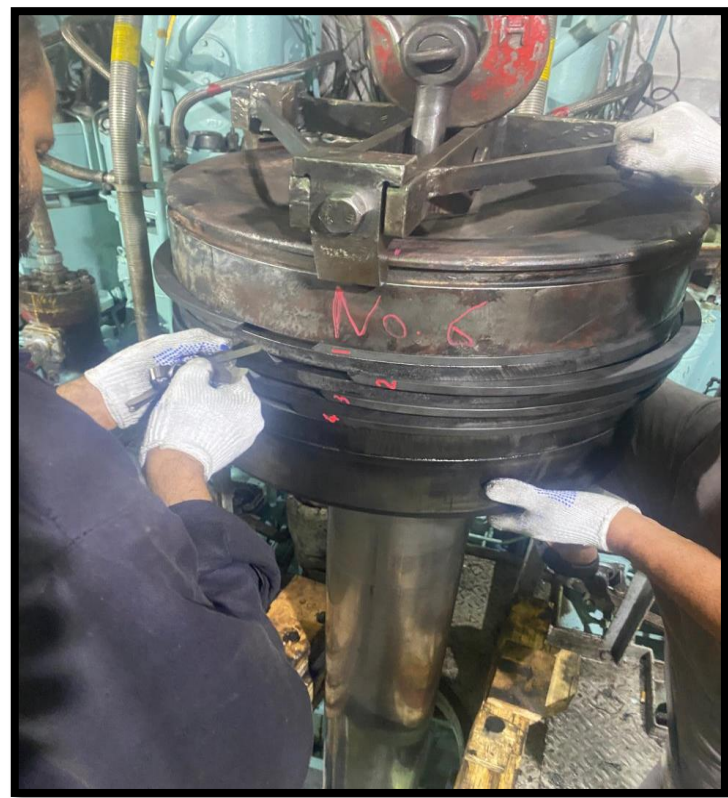
#### 5. Dismantling Cylinder cover, Piston And cylinder linear of Unit No.6

we find out a damaged in the piston rings

Then take all our measurements of the piston as shown in the pictures

All measurements in millimeter (mm)  
The crown clearance was taken in 4 points  
Max.= 0.3 mm                      Min.= 0.1 mm

So, we clean the piston, stuffing box and clean all grooves of piston

Finally, we install a new rings, piston and cylinder cover

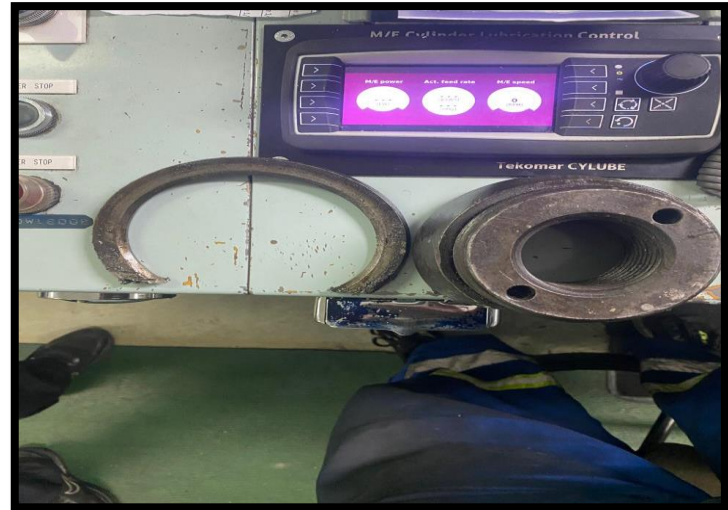
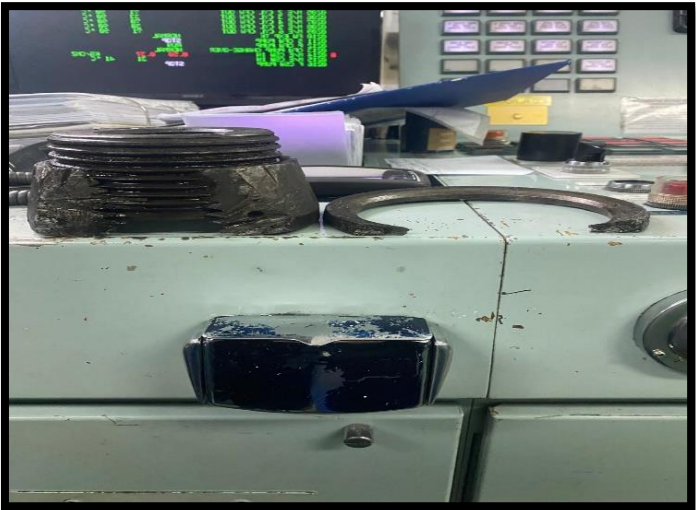
- Additional work out of our agreement:
- 1. Fix the hydraulic pump
- We fixed the hydraulic pump which used to dismantle and tight the cylinder cover nuts  
We take about 3-4 hours to reach 900 bar manually
- 2. Cut the nut of unit No. 2
- Because of O Ring seal leakage, we had to cut the nut and replace the seal and dismantle the nuts
